**DAM MASS RATING, A GEOMECHANICS CLASSIFICATION, OF THE
ROCK MASS OF DHAP DAM SITE, SHIVAPURI-NAGARJUN NATIONAL
PARK, CENTRAL NEPAL**

**CENTRAL DEPARTMENT OF GEOLOGY
TRIBHUVAN UNIVERSITY
Kirtipur, Kathmandu
NEPAL**

In Partial Fulfillment of the Requirement for the Award of Degree of Master of
Science in Engineering Geology

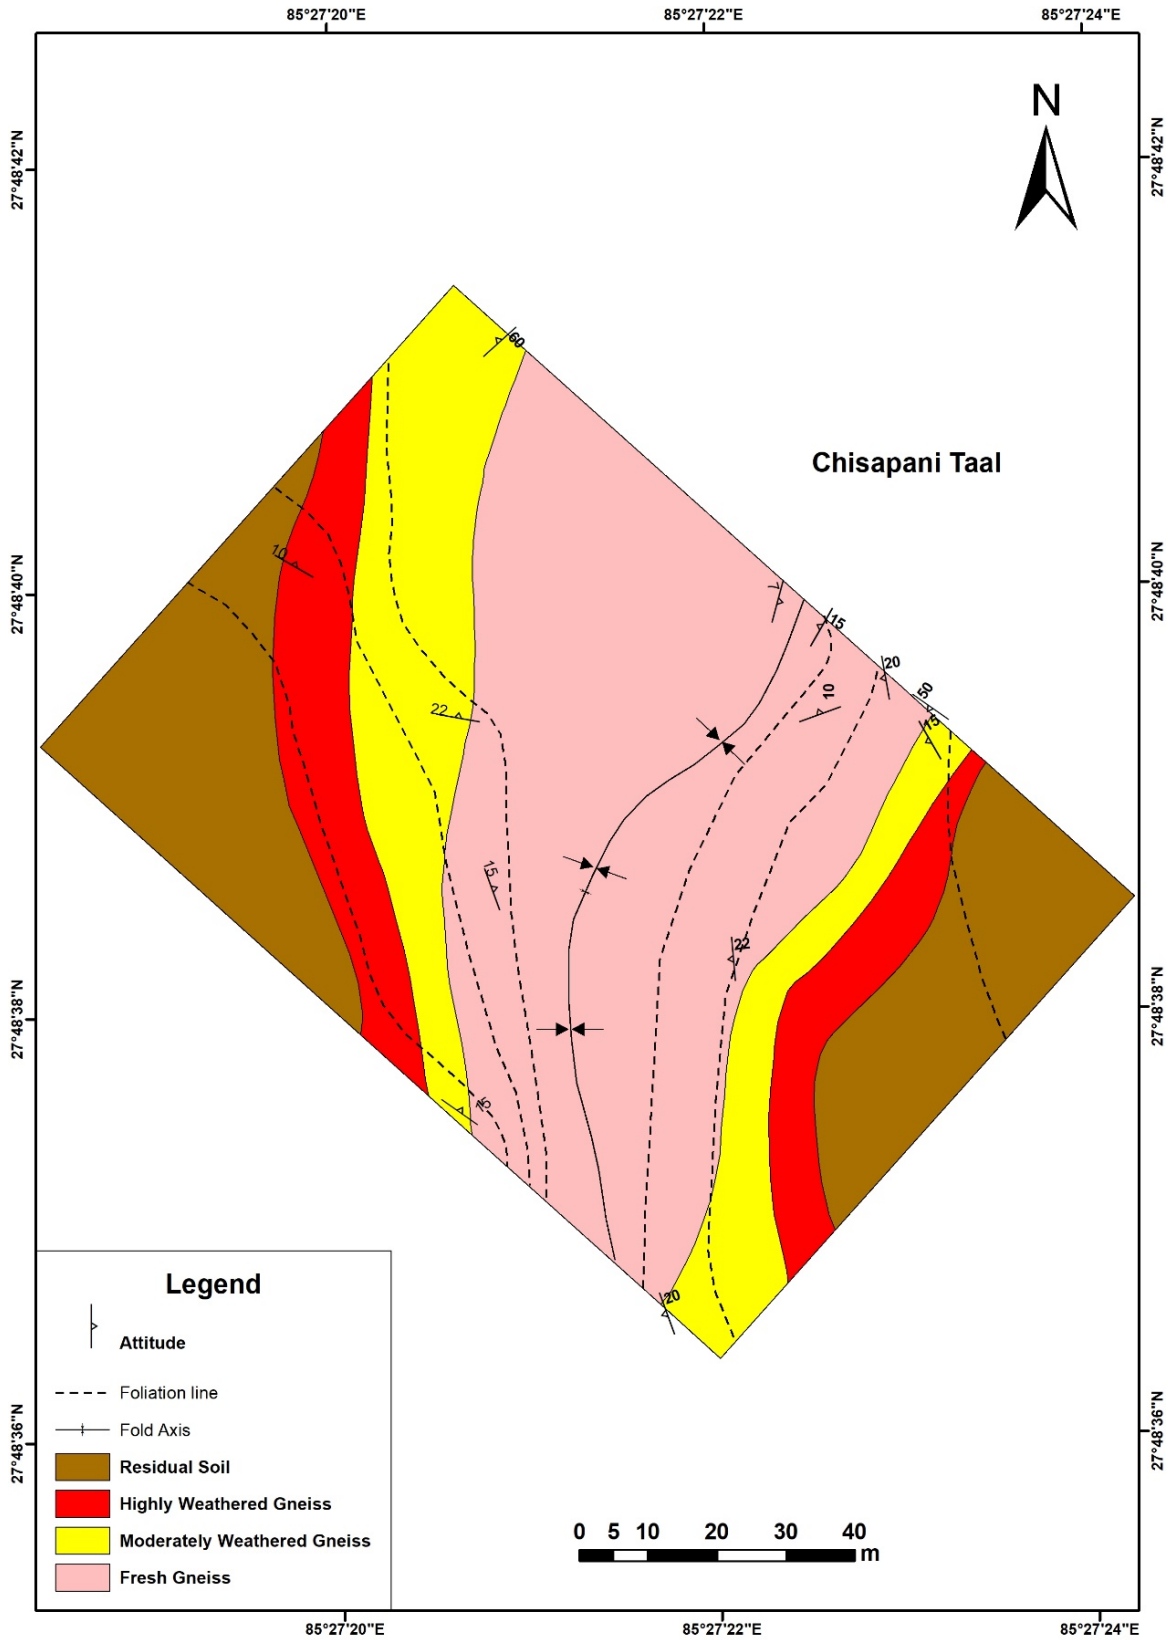
Figure 6. Structural map of the study area

Structurally, the rocks were folded in micro to meso scale. A synform running almost along the middle of the stream channel was identified, which dipped towards the stream. Three joint sets were observed, dip ranging from the horizontal to the vertical, minor faults and shear zones were also observed (Figure 6).

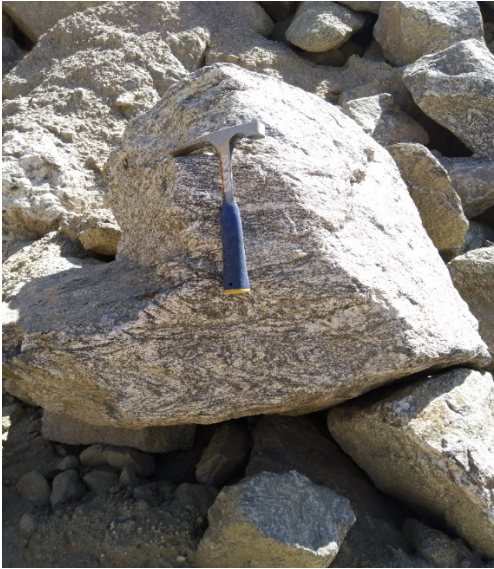
Plate 1: Microfold of gneiss band in a boulder

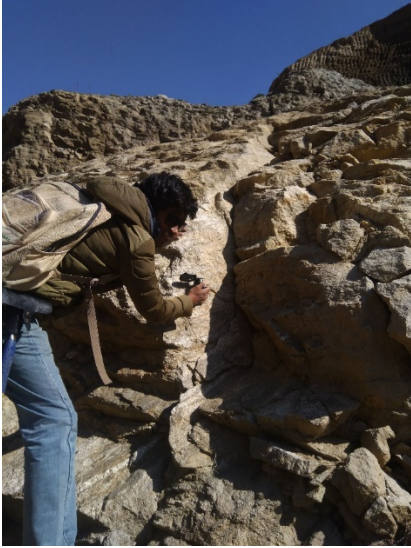
Plate 5: Fresh gneiss, at the left bank, dam axis
